PHASE I INSPECTION REPORT
NATIONAL DAM SAFETY PROGRAM
CORNWALL UPPER RESERVOIR DAM
I.D. No. NY 604
DEC DAM No. 195B-1148 LOWER HUDSON RIVER BASIN
ORANGE COUNTY, NEW YORK

PHASE I INSPECTION REPORT
NATIONAL DAM SAFETY PROGRAM

Name of Dam: Cornwall Upper Reservoir Dam
(I.D. No. NY 604)

Dates of Inspection: 8 January 1981
11 March 1981

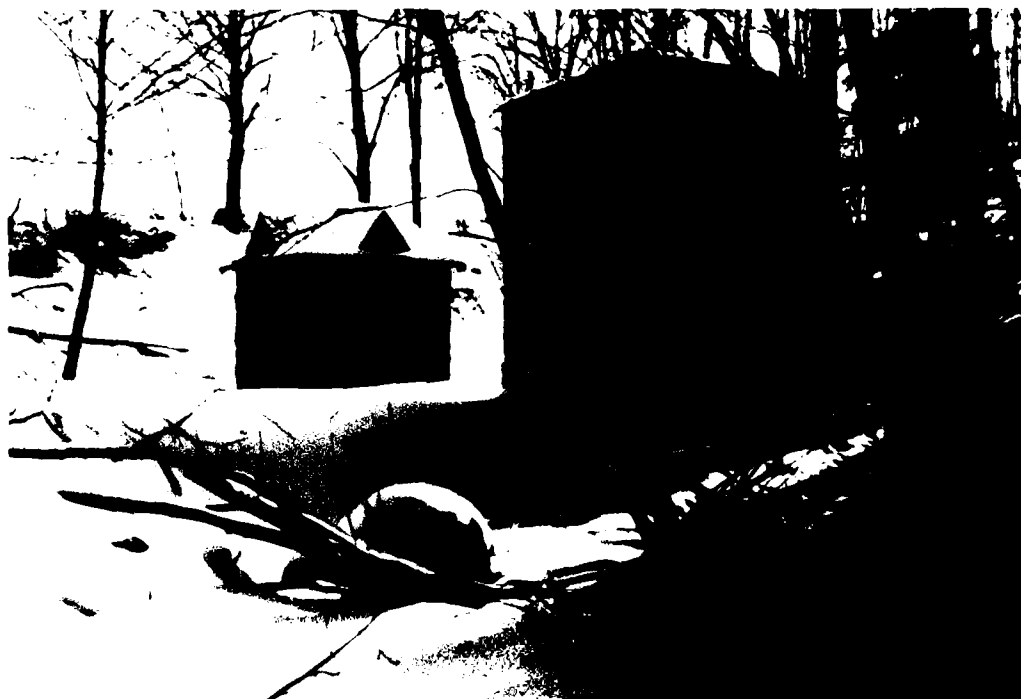
Two gate houses are situated immediately downstream of the dam. The one closest to the dam has been abandoned and replaced by the second building. Single 6-inch and 12-inch pipes enter the new gate house. A 12-inch blow-off pipe exits from the gate house and outlets immediately to the stream. A 12-inch water supply pipe leads to the filter house further downstream.

Photo 4. Gatehouse and 12-Inch Blow-Off Pipe Outlet
(Looking Upstream)
8 January 1981
